Columbia Jetty Repairs

**Project Will Shore Up Structure
Until More Permanent Fix Can Be Made**

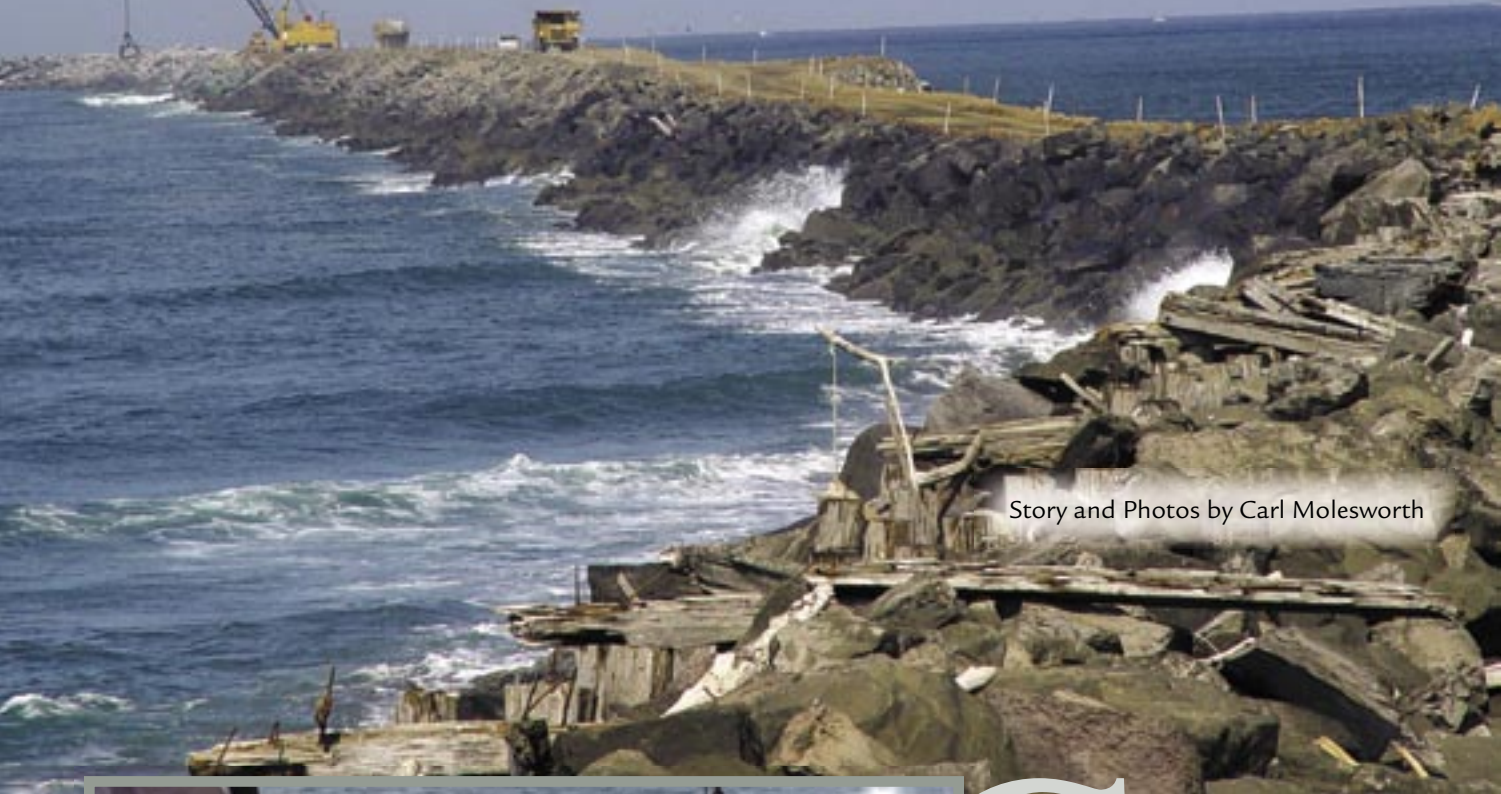
Left: The last repairs on the Columbia River south jetty were made in 1982.

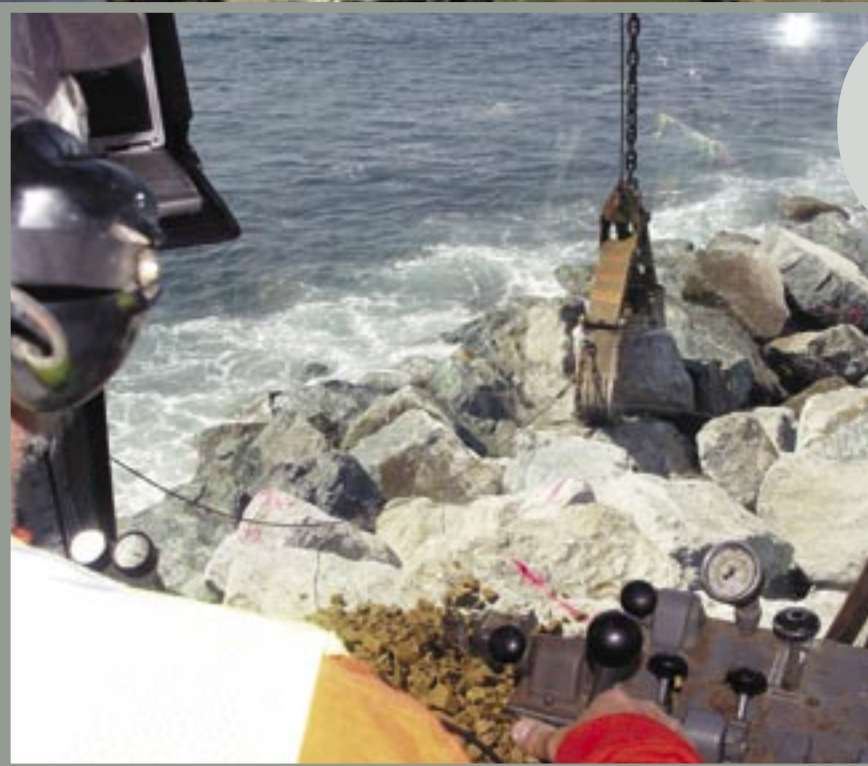
Crane operator Bill Pankey carefully places a stone on the jetty.

The contractor is using Manitowoc 4600 Vicon crane, specially built to handle the increased side loads of jetty work, to place the rocks, said Morris Frazier, corps project engineer. The crane picks each rock with its grapple from the place where it has been dumped on the haul road, swings it out over the ocean next to the jetty and then puts it down in the most appropriate spot to improve the strength of the structure.

The crane operator, Bill Pankey, is in constant communication with a spotter on the jetty and also with the laydown yard. He radios in orders for specific-sized rocks based on the voids he sees in the jetty ahead of him.

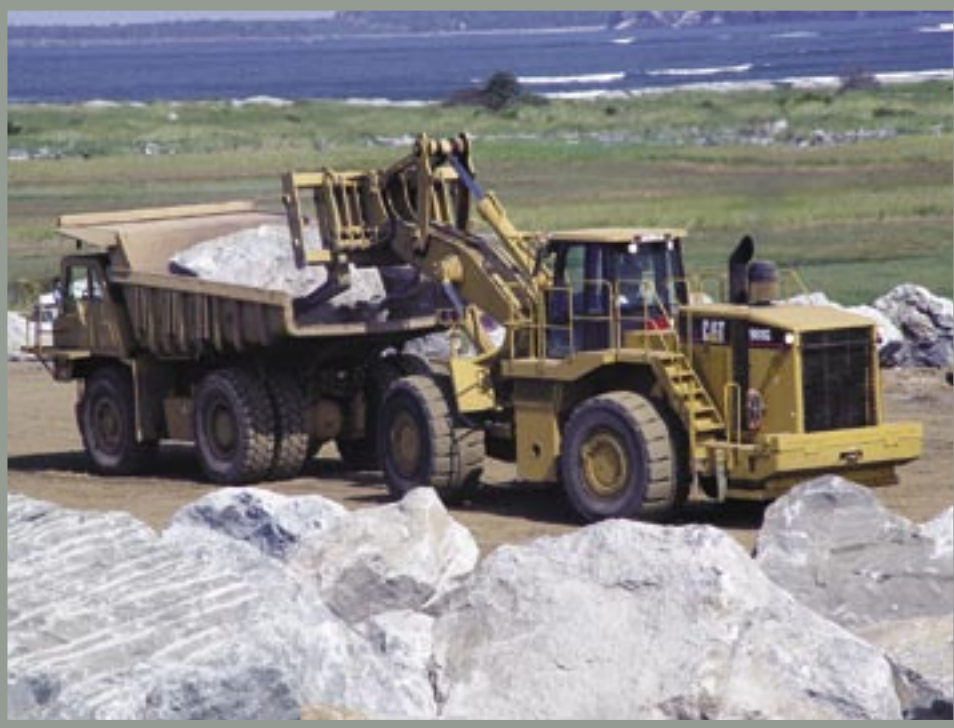
Right: A Caterpillar 988G fitted with forks loads an armor stone into a Cat 769C haul truck for delivery to the jetty.

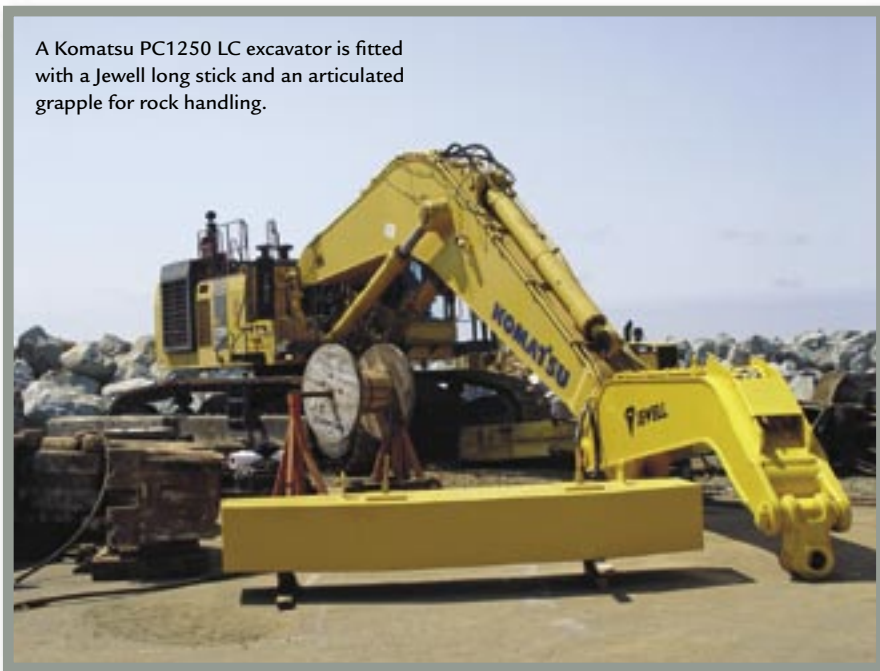
A Komatsu PC1250 LC excavator is fitted with a Jewell long stick and an articulated grapple for rock handling.

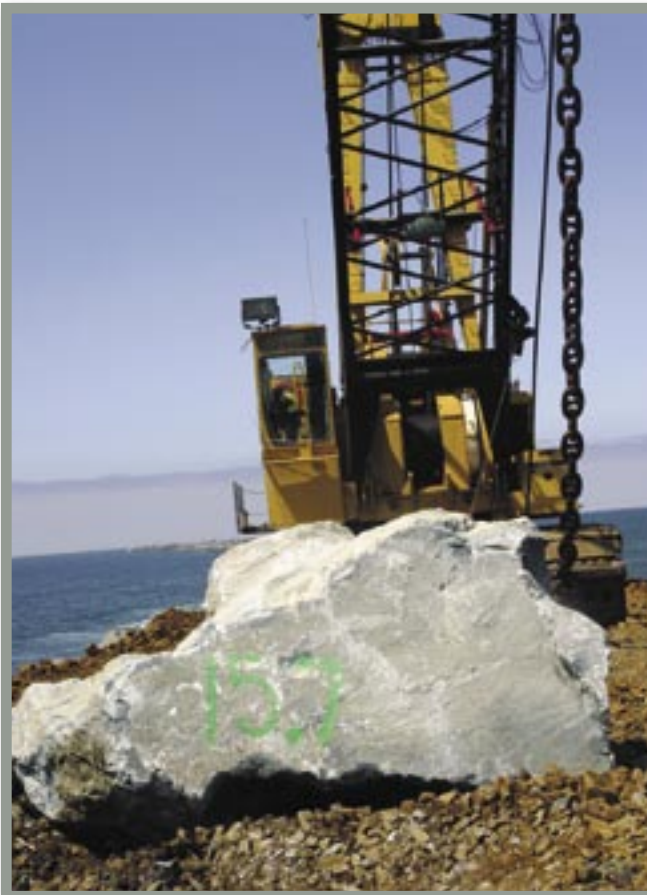
Kiewit Pacific's Manitowoc 4600 Vicon crane prepares to pick a 15.7-ton rock.

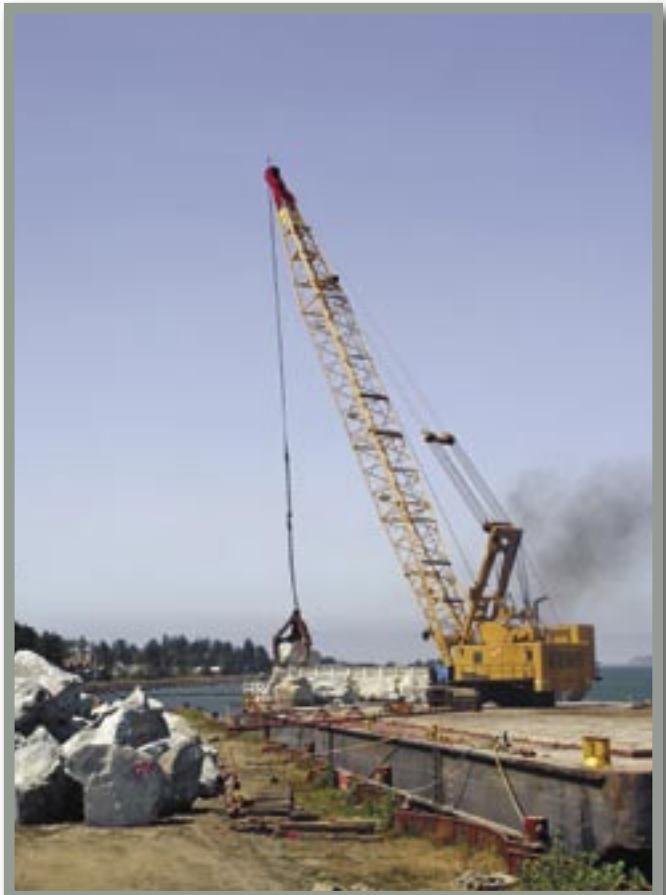
A second Manitowoc 4600 Vicon crane offloads rocks from the Kiewit barge at the Nygard Logging dock in Warrenton, Ore.

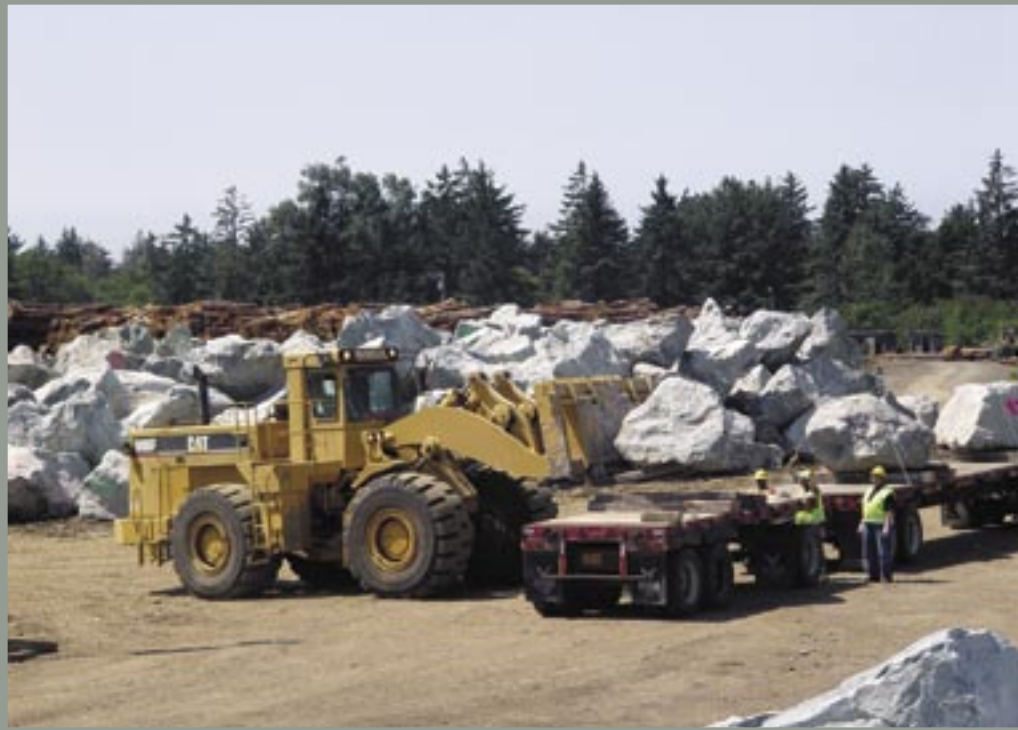
A Cat 988F loads a rock at the Nygard Logging yard.
